### Pieces of Touro Synagogue

Documentation on the Restoration of Touro Synagogue's Antique Metal Artifacts 2005-2006

by Newmans, Ltd. of Newport, RI
www.newmansltd.com

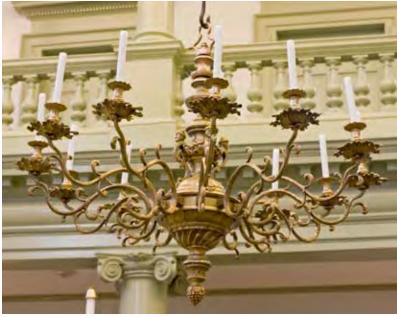
Before: Perhaps the most celebrated object in the sanctuary, the core, candle cups and drip plates are made of cast brass, and the arms of cast bronze. The uppermost element of the core, as can be seen in the 'After' image, was cast in the 1960s, and bears the stamp of Touro member Ben Helfner. As a result of the structural corrections done in the early 1990s by Newmans, Ltd., the only present structural issues were several bent arms. After years of service, the surface was oxidized and dirty, with accumulations of candle wax.

In process: All parts have been corrected, finished, lacquered and ready for assembly.

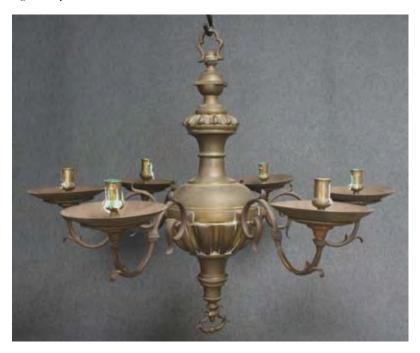
Before: The larger drip pans were added in the 1959 restoration, and are out of character with the classic design. They have not been reinstalled.

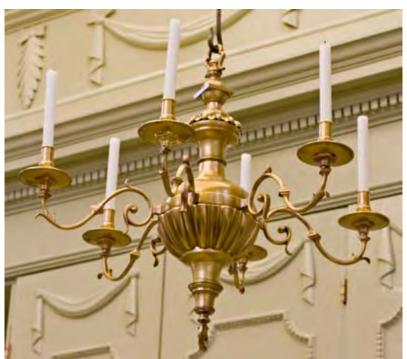
After: Since the original bobeches are missing, and the inappropriate drip pans have not been reinstalled, we have recommended that the bobeches be replaced by new, custom bobeches which would be consistent with the original design.

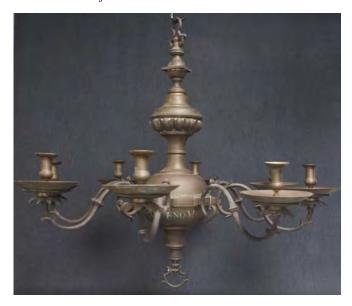
Before: This set is a variation on the design of the 6-light pair at the front of the sanctuary. Note the similar arms and similar but differently placed motifs on the core. Similar to the 6-light set, the large drip pans were added in the restoration of the 1960s.

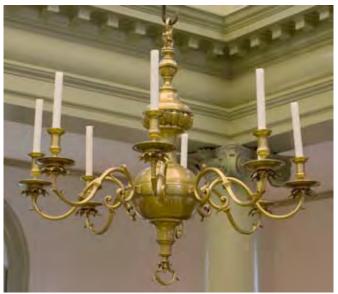
After: All arm distortions are corrected. The large drip plates (see the before image) were not reinstalled. Seven of the eight original bobeches are present (In the early 1990s, we duplicated one of these to complete the set).

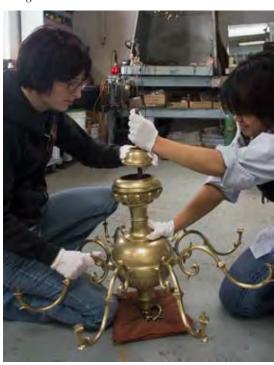
In process: The separate parts have been cleaned, polished and lacquered. Here they are being reassembled.

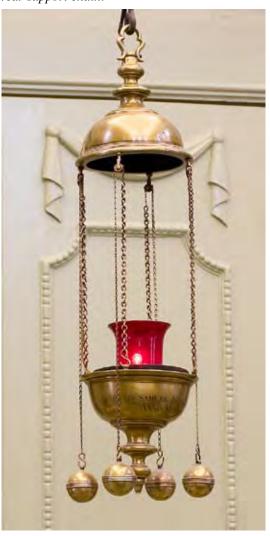
After: The new electric wire is concealed in the rear support chain.

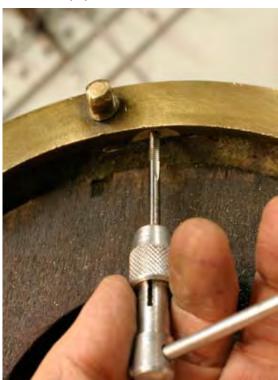
In process: To conform to local building codes, a brass grounding screw has been placed at the edge, near the entry of the new wire.

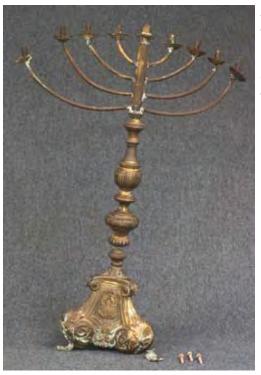
Before: The damage that had accrued before we set about addressing the problems was considerable. Its restoration required complete disassembly, reforming af all the arms and parts, creating internal structures for the central stem, reinforcing the feet invisibly from behind, and reassembly.

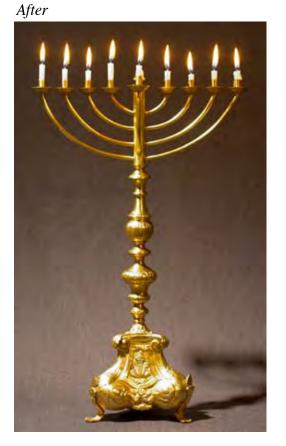
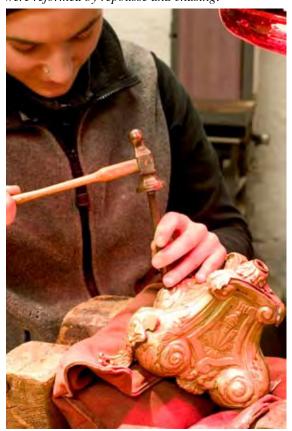
The collapsed repoussé areas on the base were reformed by repoussé and chasing.

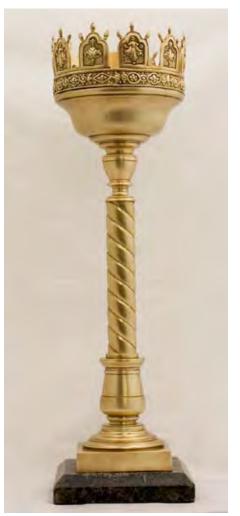
After: Note the filled right corner of the stone plinth.

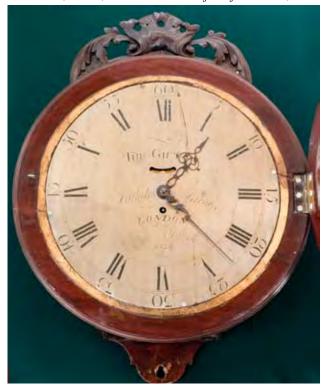
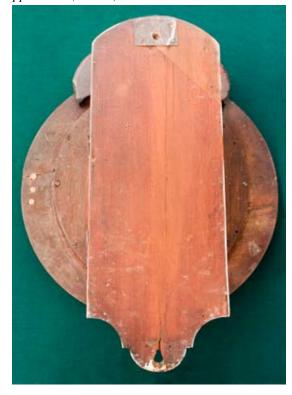
Before: Note, on the left, the dilapidated face and worn wood. Face is open to show the hinge. Note on both views, center, the three screws of the face cover, and the support hole (bottom).

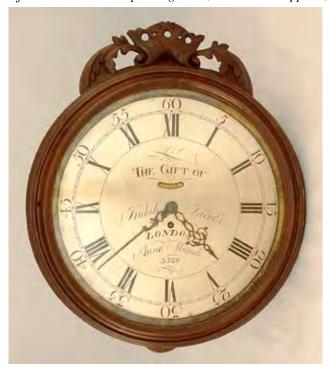
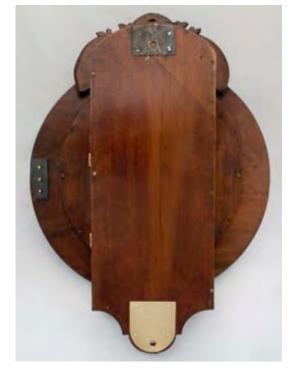
After: Note the corresponding areas, their added supports, and the corrected finish.

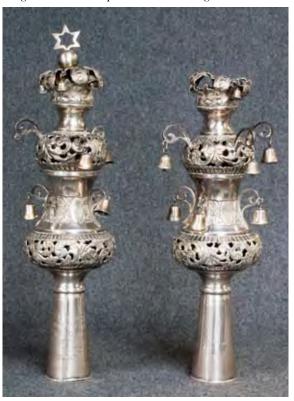
Before: The crowns were crushed; bell hanger was missing; many bells were detached; and one Magen David and sphere were missing.

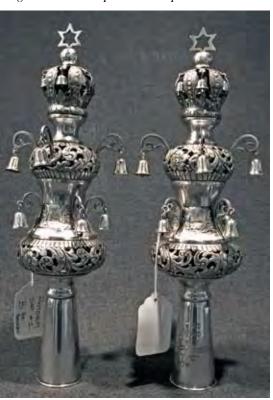
After: All parts are assembled and polished. The bells are coordinated and attached. Dents in the pierced forms have been removed. The duplicated Magen David and sphere are in place.

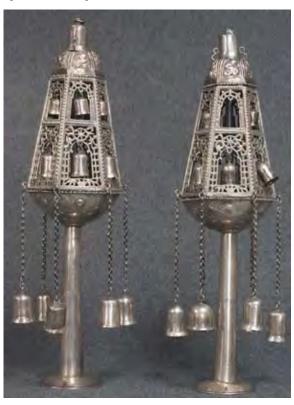
Before: Note the mismatched bells and the upside-down top elements.

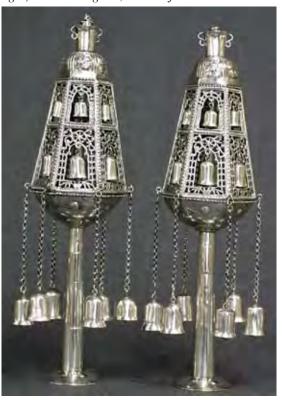
After: The tiny 'cup' finials have been correctly positioned. However, note the small top detail; we were not able to determine whether the higher (left) or lower (right) was the original, so we left each as it was.

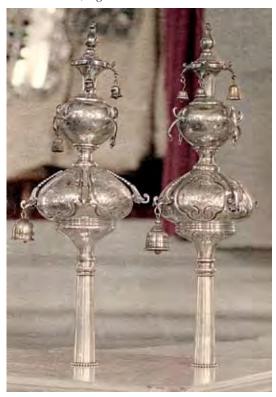
Before: Note missing bells and hangers, the bend in the central form, left, and the dent in the center section, right.

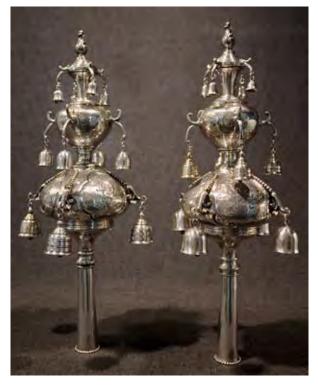
To remove the dents in the main body, we disassembled the rimonim; and, using a snarling iron, pushed out the dents. We then reassembled the parts.

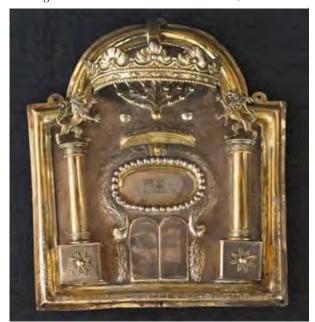
Before: When we received the piece, the bells were missing and the silver elements were oxidized.

In process: We removed the crown to facilitate cleaning. The thin gold plate, or wash, was masked while highlighting the silver, to avoid erosion. The wire suspenders had been broken. We made new links and balanced the three elements to equally support the plate.

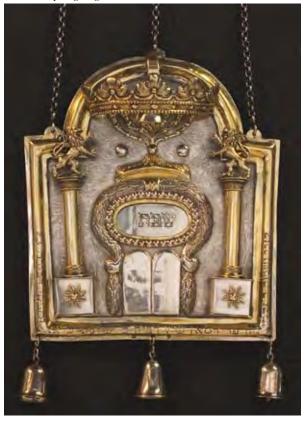
After: The bells are now attached, all the silver is selectively highlighted.

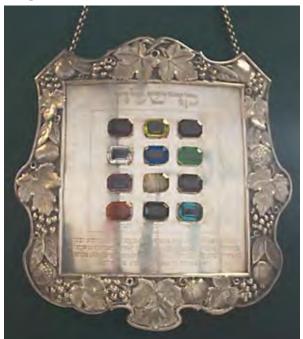
Before: The silver had been overcleaned, reducing the contrast between the letters and the polished face, and between the frame's floral reliefs and their background.

In process: All the letters and floral reliefs were darkened and the plate itself refinished. Fasteners in the rear were missing; we made new ones similar to the originals.

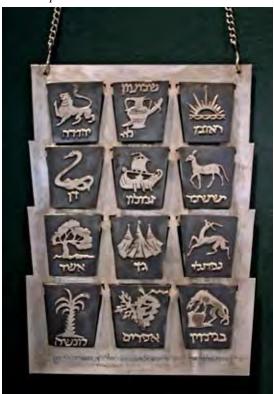
Before: The oxidized background of the individual elements was chipped on one plate, and the highlights were unbalanced. The back-plate was overpolished.

In process: The black oxide patina was restored, and the backplate brought to a more uniform finish.

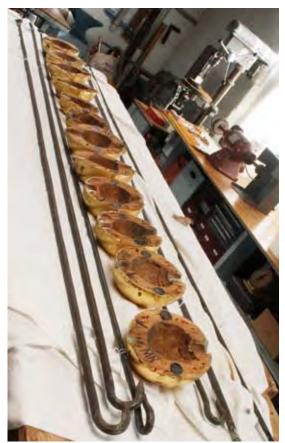
What appeared to be a straightforward disassembly revealed that the two halves had been 'toenailed,' or, connected with many diagonal, interlocking nails. After their skillful separation by the contractor, our challenge was to devise a reversible assembly system – one which, should it become necessary to once again remove them, would be as unintrusive as possible.

We added magnets to the spheres' inner faces (note the dark disks). To precisely relocate the hemispheres, we clipped the nails to 5 mm above the faces, so they would slightly enter their original holes when we snapped them together.

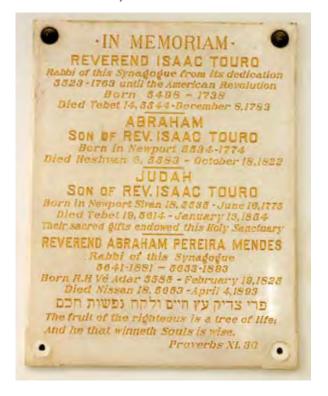
Before: The marble surface and incised letters were covered with oily soot from burning candles. This had attracted dust, which had also become affixed. The rosettes were heavily corroded.

In process: The surface was washed with a non-ionic detergent and distilled water. The incised letters were washed with a soft brush. A layer of museum quality paste wax was applied to all surfaces.

The corrosion on the rosettes was removed by immersion in an acid bath, highlighted, lacquered and waxed.

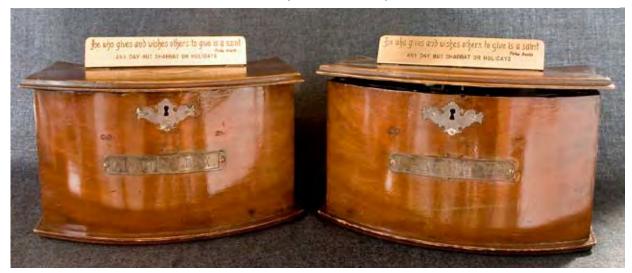
*Before:* The wood in many areas was chipped and the surface eroded. The silver escutcheon and nameplate were tarnished. The donation slots had been eroded from use over the years.

In process: To preserve the historic character of the slots, we chose not to alter their form, but only to consolidate the raw wood with lacquer. We also filled the missing gaps in the boxes' joints with colored resin, and blended eroded areas to reduce their contrast with the overall finish, taking caution not to erase the wear – evidence of the boxes' history.

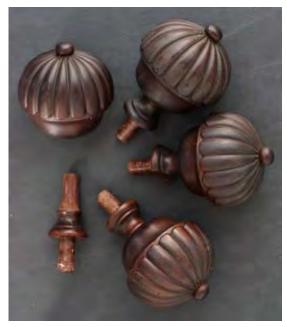
Before; finials: Note the detached neck and dowel.

In process: We cleaned all surfaces with mineral spirits. One dowel, which connects the finials to the table, was loose. We replaced it with a correct one.

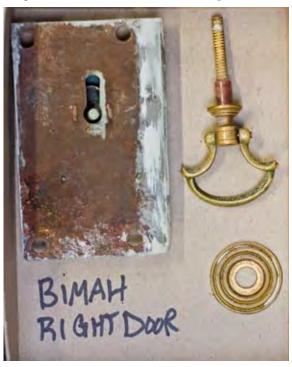
Before; Bimah hardware: The surface was rusty and caked with paint. The hasp which accompanies the brass handle was missing.

In process: We duplicated the hasp based on an extant one on the opposite door, refinished and lacquered the parts.

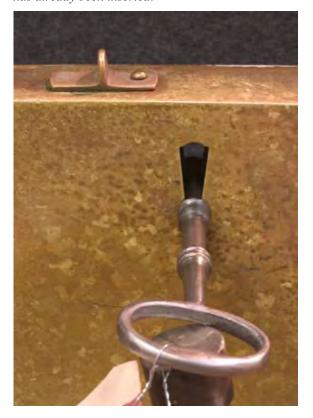
Before: View of surface and key prior to shortening. The deadbolt disabling screw has already been inserted.

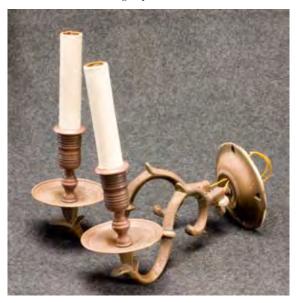
Before: The sconces were heavily oxidized, many were distorted. Yellow electric wire was substandard and unsightly.

In process: As can be seen in the 'before' image, the exposed wires were unsightly. We introduced a 5 x 10 mm long flared tube to cover this wire between the base and the arms.

The central support screws were understructured. Here, before most of the work has started, we began by putting in new, stronger supports with a large washer to distribute the stress. On some bases, a larger hex-head cap screw was used instead (not pictured).

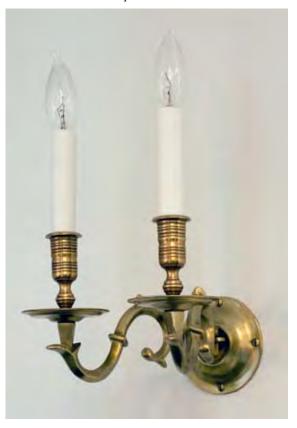
After: All surfaces were cleaned and received a heavy layer of lacquer. The electric elements and candle sleeves were replaced.

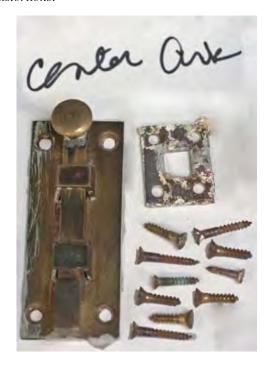
Before: All the parts were heavily caked with paint. Leather washers were used under the nail heads; the originals were completely decomposed, and covered with paint. Structurally, there were minor distortions.

*In process:* All parts were cleaned of paint and rust, straightened, and made functional.

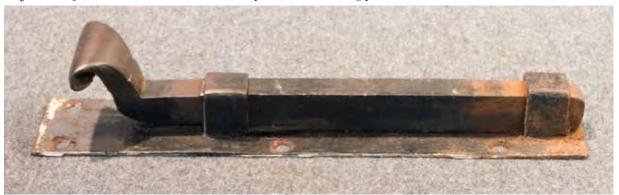
Before: Surfaces were rusted and caked with paint. the mounting plates were bent.

*In process:* To comply with the fire code, the locks had to be disabled – we installed set screws to lock the bolts open. We removed all rust and paint.
