### Pieces of Touro Synagogue

Documentation on the Restoration of Touro Synagogue's Antique Metal Artifacts 2005-2006

by Newmans, Ltd. of Newport, RI
www.newmansltd.com

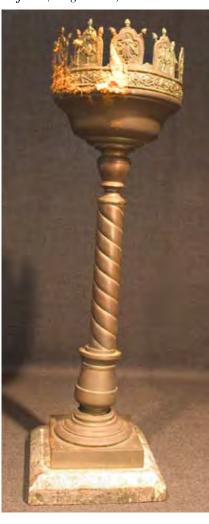
Before (Height: 24")

Bent stem section (upside down).

We replaced this candle cup –clearly jerry-built sometime in the stick's history – with the new, 6" diameter bobeche (below).

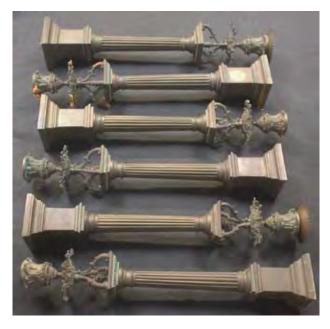
These are good examples of the quality which can be achieved in casting decorative objects. Each candlestick is composed of fourteen parts which fit together like a precision puzzle. The structural issues we dealt with were only minor – refitting of the four-legged sections atop the columns.

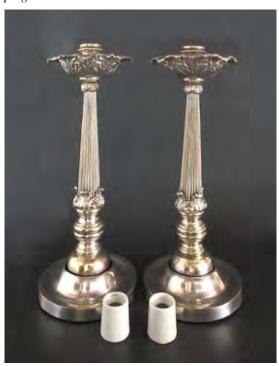
After: Included here are the porcelain followers, which partially succeed in keeping wax from dripping into the dishes.

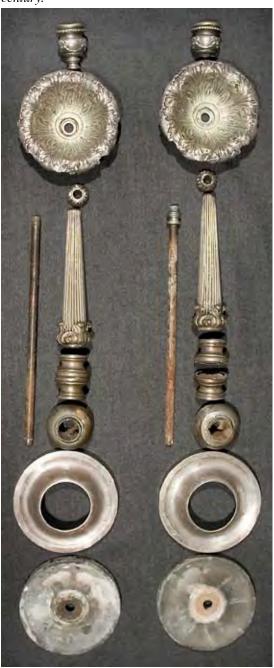
In process: The disassembled parts show that these were made in the Industrial Period; the parts were built around a central, threaded pipe similar to that used for electric lamps during the 20th century.

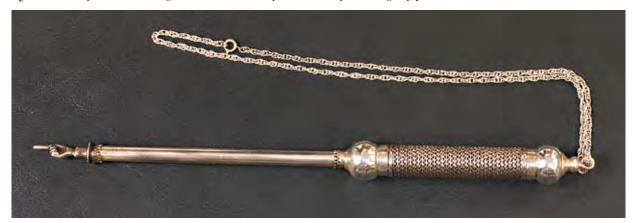
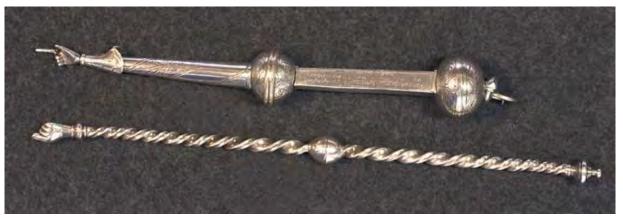
After: These yadim were in good condition. They needed only to be lightly polished.

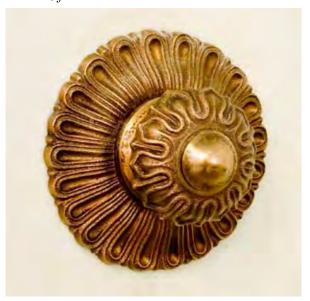
Detail, finished rosette

Before: The marble surface and incised letters were covered with oily soot from burning candles. This had attracted dust, which had also become affixed. The rosettes were heavily corroded.

The corrosion on the rosettes was removed by immersion in an acid bath, highlighted, lacquered and waxed.

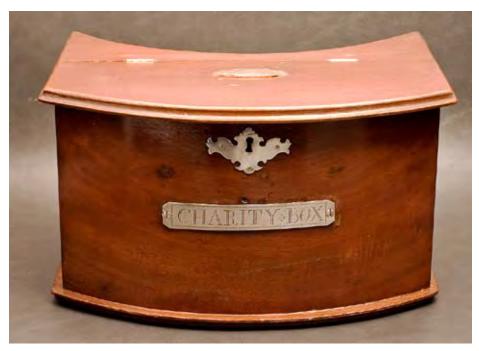
After

*Before:* The wood in many areas was chipped and the surface eroded. The silver escutcheon and nameplate were tarnished. The donation slots had been eroded from use over the years.

In process: To preserve the historic character of the slots, we chose not to alter their form, but only to consolidate the raw wood with lacquer. We also filled the missing gaps in the boxes' joints with colored resin, and blended eroded areas to reduce their contrast with the overall finish, taking caution not to erase the wear – evidence of the boxes' history.

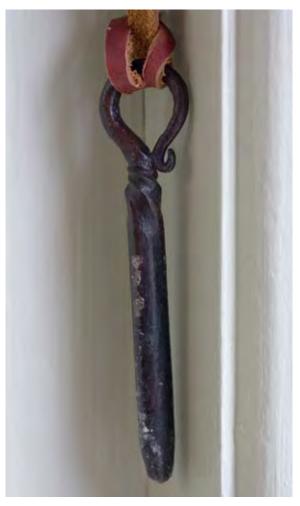
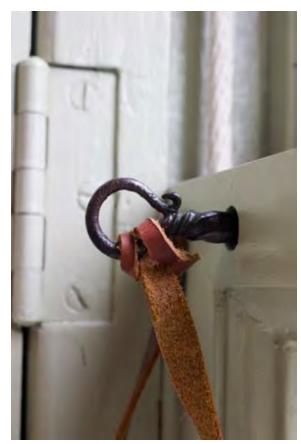
The design of the pins indicate that they were made in the restoration of the 1960s. We succeeded in locating the same blacksmith, who then made the replacement pins for us. The leather straps were supplied by Shawmut Design & Construction.
